Locating NEXT Problems

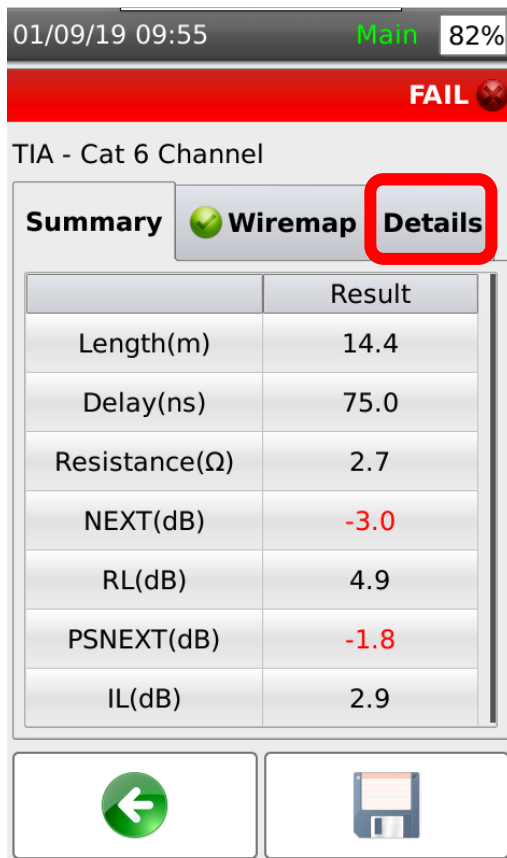
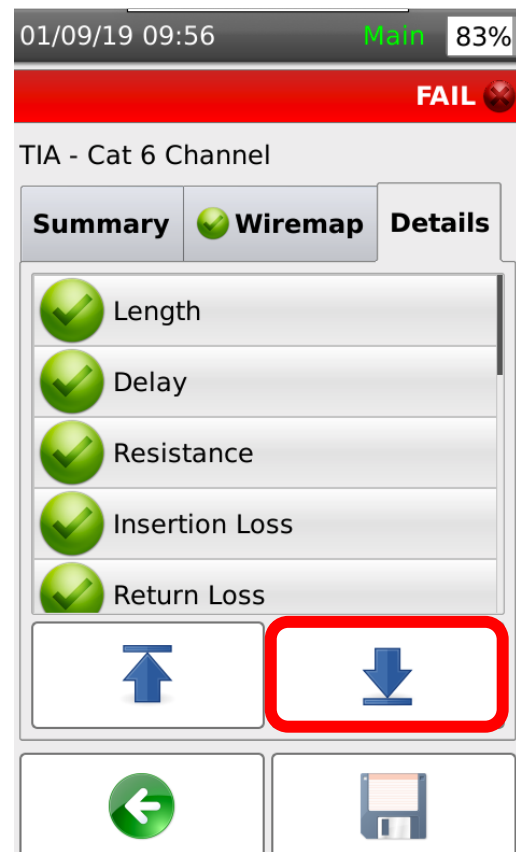
2. From this screen, press the
down arrow 3x to get to the
NEXT Locator

1. Start with Autotest Summary
NEXT failed, but why?

Press the Details softkey

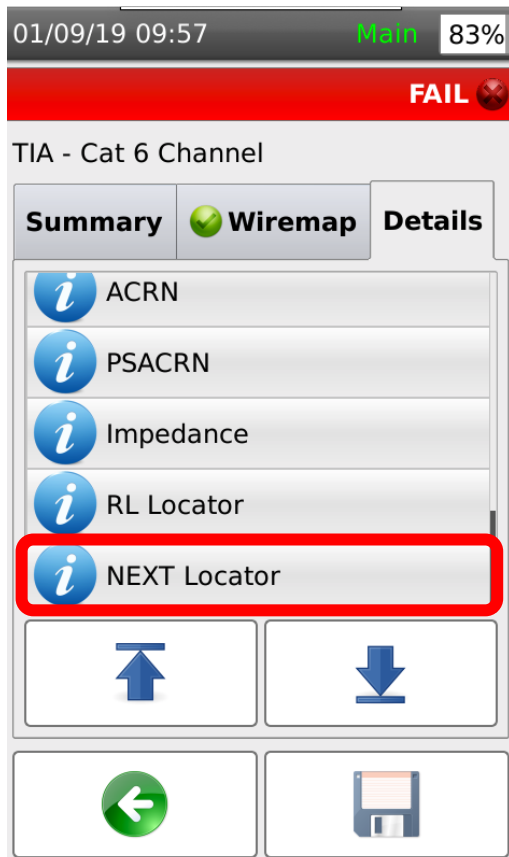
3. Press NEXT Locator

There are a several observations you can make about this link. First, the failure is due to a spike in NEXT about 8m away from the main unit, at a connection. There is also a lesser NEXT issue about 5m away. In addition, if you look closely at the picture you'll note the NEXT in the cable from 0 to 5m is much better than the NEXT performance of the cable between 8 and 13m.

Expert users can use the left/right scroll keys and + - zoom keys to get more detail.

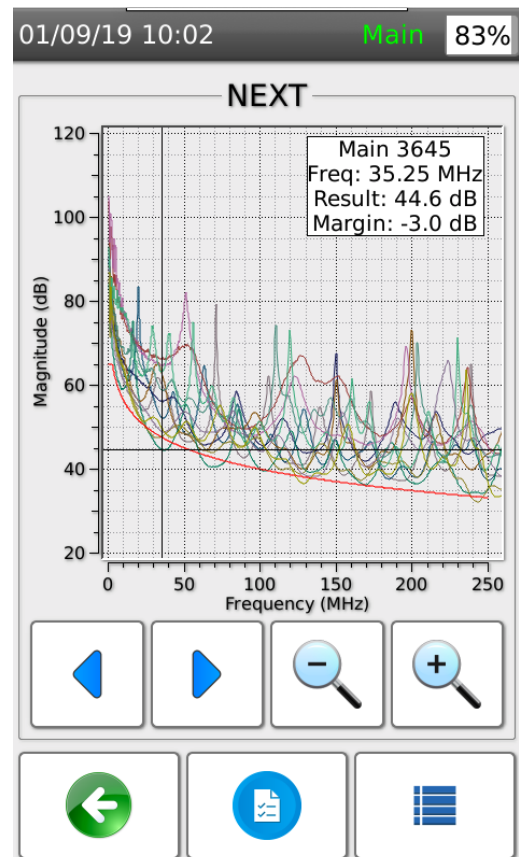
4. Test Result Screen

Note that the TestPro also provides a full graph of the NEXT performance. You can see in the example below that the NEXT crosses the pass/fail line at several frequencies. This data is helpful for expert users but will not help the average user find the location of the NEXT failure so it can be repaired.
