Ensuring Shield Integrity in Field Testing

SMART BUILDINGS TECHNOLOGY

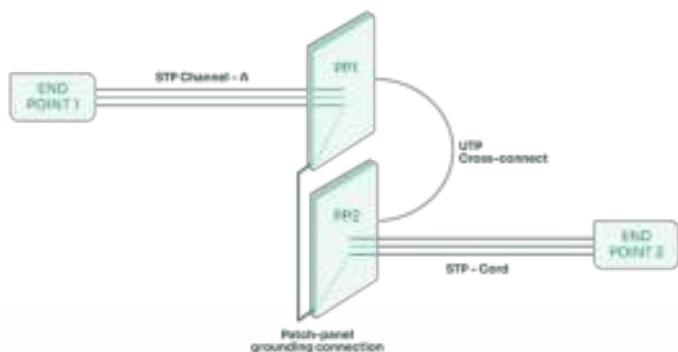
Fig 1 – DC continuity present but shielding compromised

Commonly, shield integrity is verified by simple DC continuity measurements. However, there are situations where shield integrity might be compromised despite having end-to-end DC connection of the shield conductor. Even when the channel has one or more unshielded components, there may be an alternate DC conduction path, for example, through grounding of the patch-panels (Fig. 1). When such alternate conduction path is present for shield, simple continuity measurement may give a false PASS. The good news is, even in such cases, testers like TestPro and NSA can detect shield discontinuities through AC (RF) measurements. Further, these tools pin-point the location where shield discontinuity is detected, which is extremely useful information while troubleshooting the shield issues.

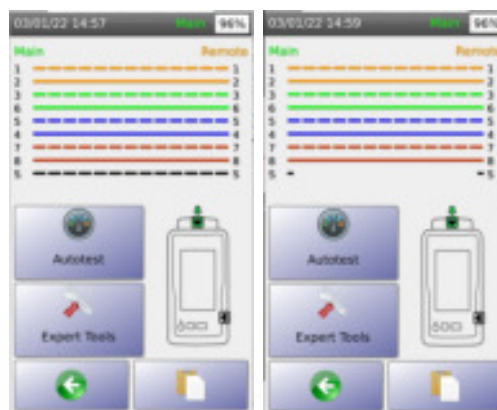
Fig 2 – Cable with good shielding and broken shield (DC shield discontinuity)

First, a regular check on DC continuity is performed using wiremap measurement. Fig. 2 shows two scenarios, one with good shield, and second with open shield. After performing DC continuity check, as an integral part of the RF measurements, the tester performs a special type of measurement called CMRL (common mode return loss) on each pair of the cabling. By analysing the variations on CMRL along the length of the cable, shield defects and be accurately identified (even in the presence of alternative DC conduction path). Let's look at how this is done.

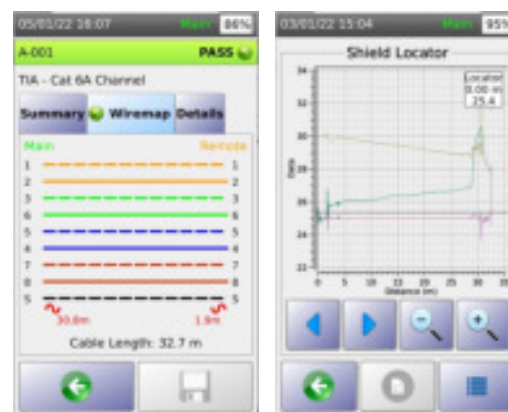
Fig 3 - Cable with AC shielding discontinuity and its time domain locator plot

As seen from Fig. 3, a cable having AC shield discontinuity is detected by the tester accurately. The tester also provides a locator (time-domain) plot of the measurement for in-depth analysis of the cable behaviour.
